Galvafacts

Staining and discolouration of galvanized steel by rust

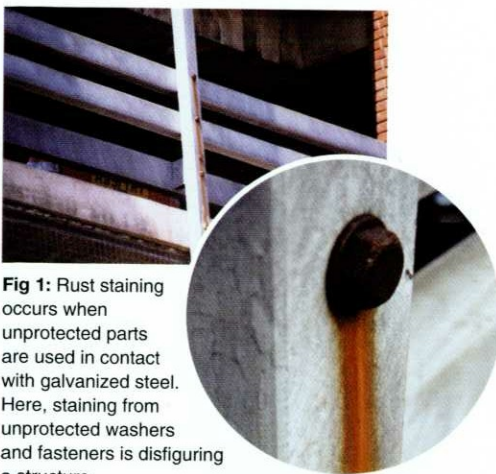
Fig 1: Rust staining occurs when unprotected parts are used in contact with galvanized steel. Here, staining from unprotected washers and fasteners is disfiguring a structure.

- 1: Direct contact of galvanized parts with unprotected or inadequately protected steel (e.g. galvanized steel sections fastened with unprotected, electroplated or painted steel bolts).

All parts of the structure should receive comparable corrosion protection where possible. Nuts and bolts and other fasteners should be hot dip galvanized to BS 7371: Part 6: 1998. The thinner zinc coatings frequently supplied on steel mesh, sheet, wire and tube will not last as long as those of products hot dip galvanized to BS/IS EN ISO 1461, the standard which covers all structures galvanized after fabrication.

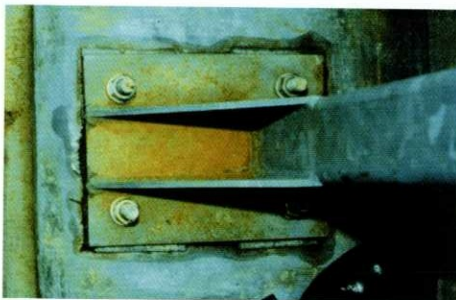
Fig 2a: When steel is cut or drilled after galvanizing, the swarf must be removed. If it is left on the component rust staining may occur.

- 2: Deposits of iron dust and swarf from other operations or sources onto the galvanized surface.
- 3: Water draining from unprotected or poorly protected steelwork, e.g. from damaged areas on painted steelwork.

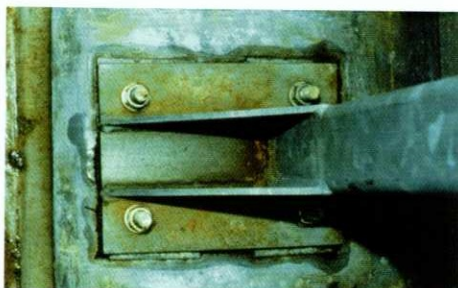
Fig 2b: This staining is superficial and can be removed to expose a sound galvanized coating beneath.

Discolouration and staining have no effect on the life of the coating. However, affected areas may be cleaned to improve the appearance of the structure. Generally, wire brushing or the use of a scouring powder will remove the stain and leave a sound galvanized coating.

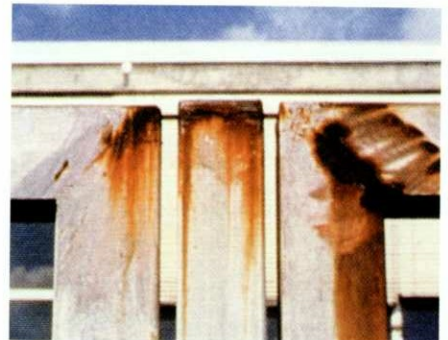
Fig 3: Where galvanized structures are welded, the steel exposed must be adequately protected (see text). Where this is not done, severe rust staining occurs as shown in this illustration.

- 5: Rusting of areas welded after galvanizing and subsequently left unprotected or inadequately protected.
- 6: Staining of galvanizing can occur when water runs off other materials notably metals such as copper, certain hardwoods, e.g. oak, and indeed whenever water can dissolve materials from one surface and redeposit on the galvanized steel.

Where welding after galvanizing is necessary, welded areas should be thoroughly cleaned and the zinc coating restored either with an appropriate thickness of zinc rich paint or with a proprietary repair compound, in accordance with section 6.3 of BS/IS EN ISO 1461.

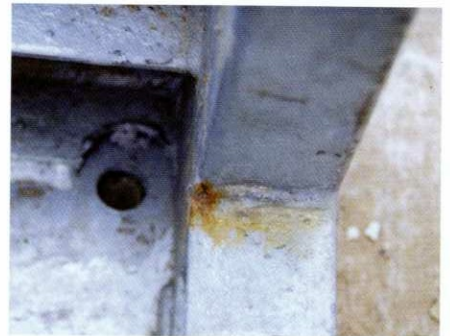
Fig 4: Seepage from pretreatment solutions from a weld

- 4: Seepage from pickle residues in welds. During pickling, hydrochloric acid may penetrate into the weld area via pin holes or if the welding is intermittent. Residual salts can sometimes pick up water and cause 'weeping' from the weld areas. This effect is normally limited to a small area, ceases after a short time and is not detrimental to the coating.

Welds should be continuous and slag-free wherever possible to minimise the retention of pickle residues.

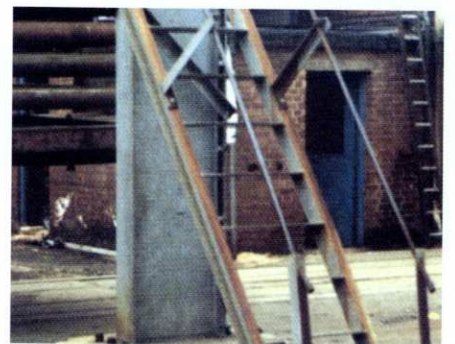
Fig 5: Water draining from rusting steel (out of picture) causes staining of sound galvanized surfaces of the stairway illustrated here.

Design structures to avoid run-off water from other metals on to galvanized steel. In particular avoid run-off from inadequately protected steel and from copper.
